VOL. 1

INTRODUCTION

Introduction

Examples of Phase I Findings

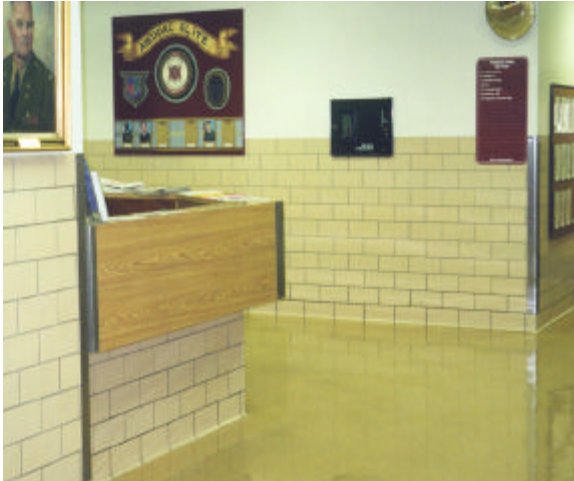
Lack of Sense of Space and Place: The absence of wayfinding elements, such as color accent tiles in corridors makes it difficult to differentiate locations within the facilities.

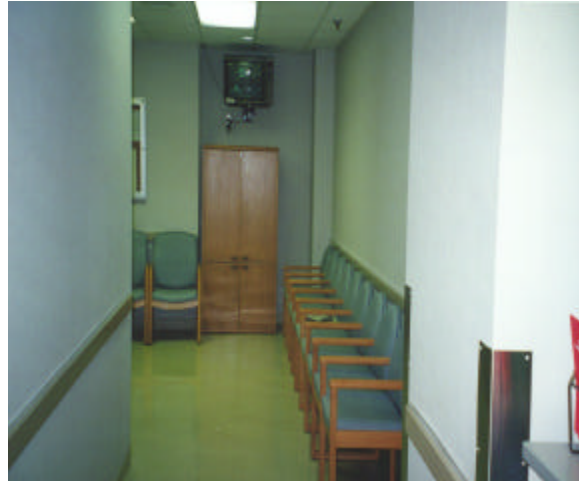
Non-Standardized Materials and Finishes: The use of too much color and texture overwhelm the space and too little texture and color makes the surroundings seem lifeless.

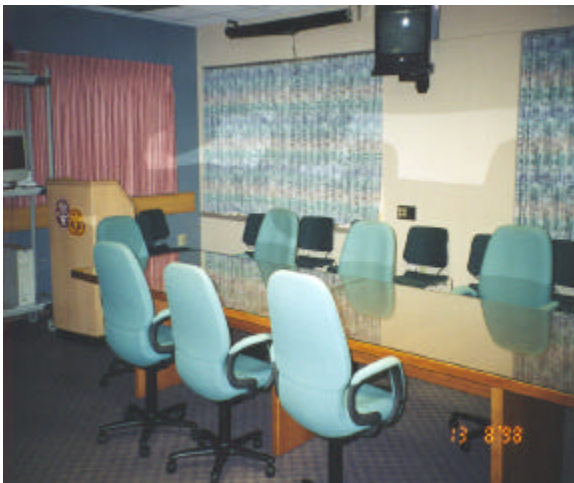
Inappropriate Use of Materials and Finishes: Cubicle curtains as window treatments in a conference setting is inappropriate.

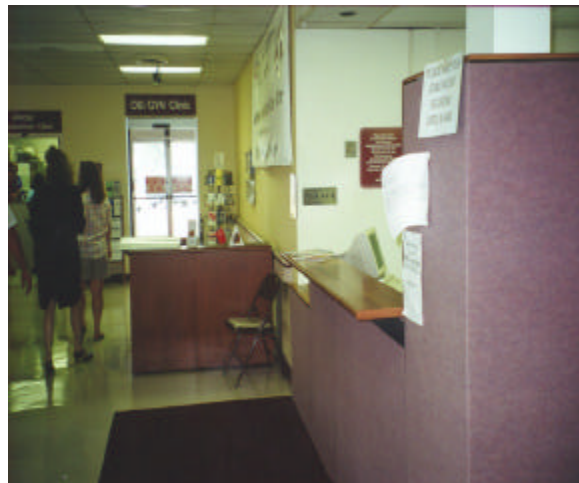
Lack of Visual Organization: Random selection and application of products contribute to the breakdown of visual organization.

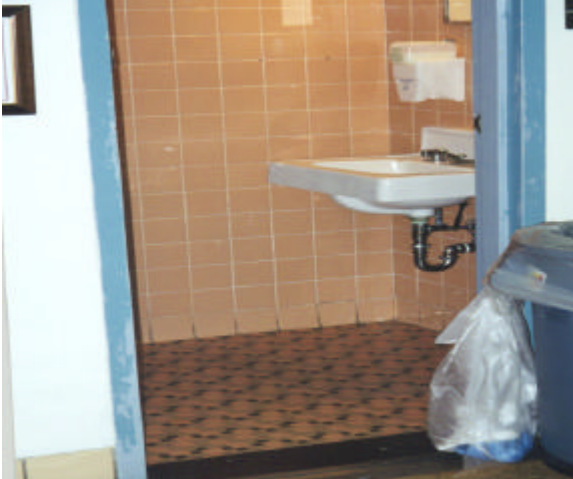
Outdated Appearance: The use of “trendy” colors and styles dates the facility’s appearance.

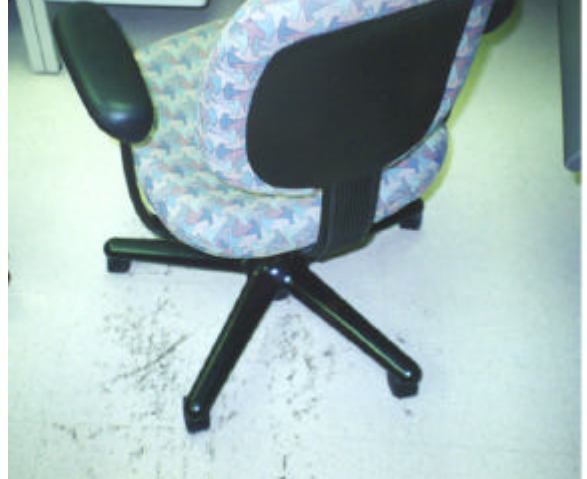
Hard to Maintain: Scuff marks on vinyl composition tile from chair casters rolling across the bare floor are difficult to remove.

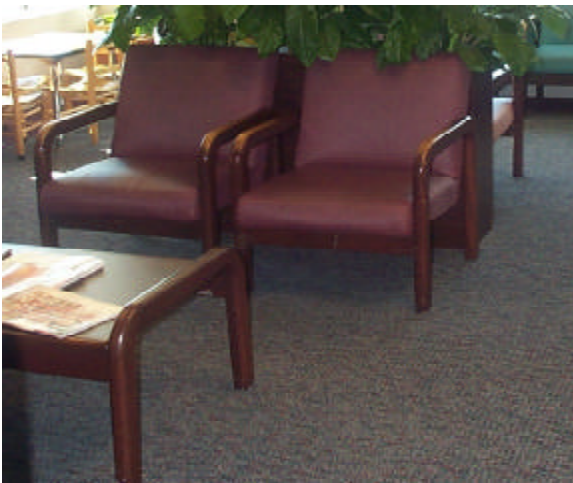
Uncomfortable and Unfriendly Environments: Cracked and worn finishes contribute to an unwelcoming environment. Oversized plants interfere with seating.

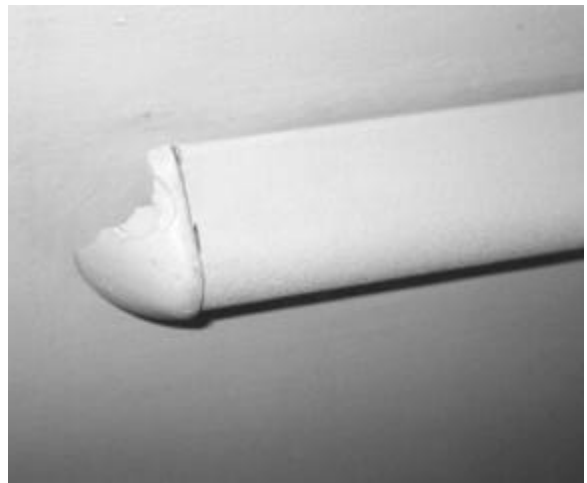
Materials Need Replacement: Cracked wall protection causes a safety hazard and visually makes the facility seem unkempt.
